*U.S. Department of Energy
Office of Legacy Management*

2006 Annual Site Inspection and Monitoring Report for Uranium Mill Tailings Radiation Control Act Title I Disposal Sites

December 2006

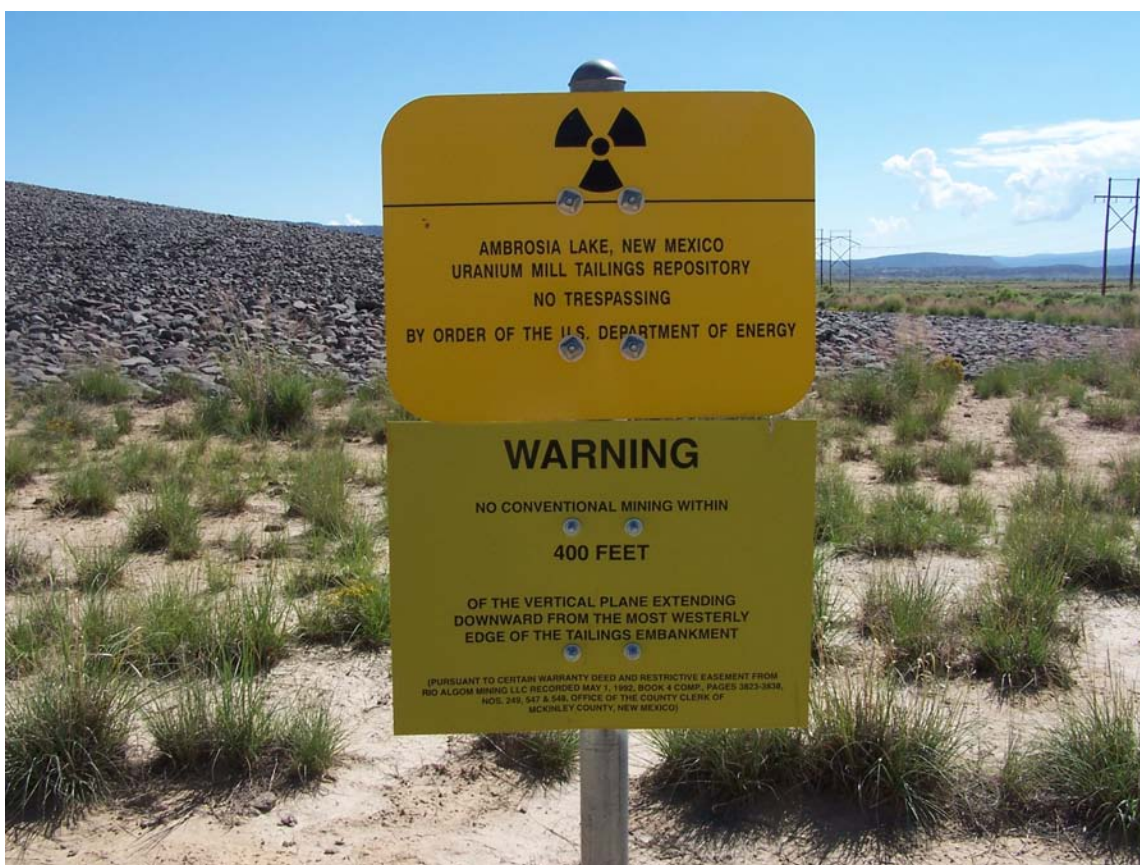
The entrance sign and all perimeter signs were in good condition. Posts for perimeter signs P1 through P15 include mining restriction area warning signs (PL-1).

AMB 8/2006. PL-1. Perimeter sign P2 with the restrictive easement warning sign below.

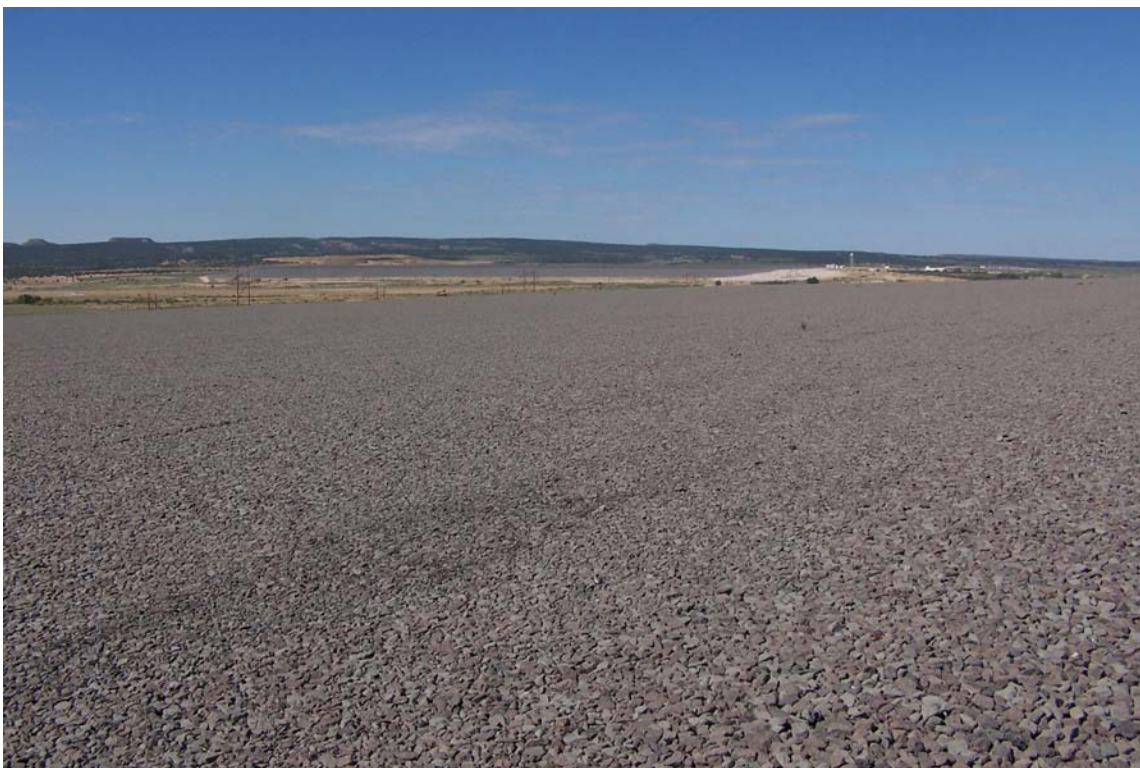
Top of Disposal Cell—The disposal cell was completed in 1994. The basalt riprap-covered top of the disposal cell is in excellent condition (PL–2). There was no evidence of cracking, settling, slumping, or erosion. Repairs were made in August 2005 to a shallow depression in the cell cover around settlement plate SP–4; the repaired area was in good condition (PL–3).

AMB 8/2006. PL-2. View of the disposal cell top from settlement plate SP-3.

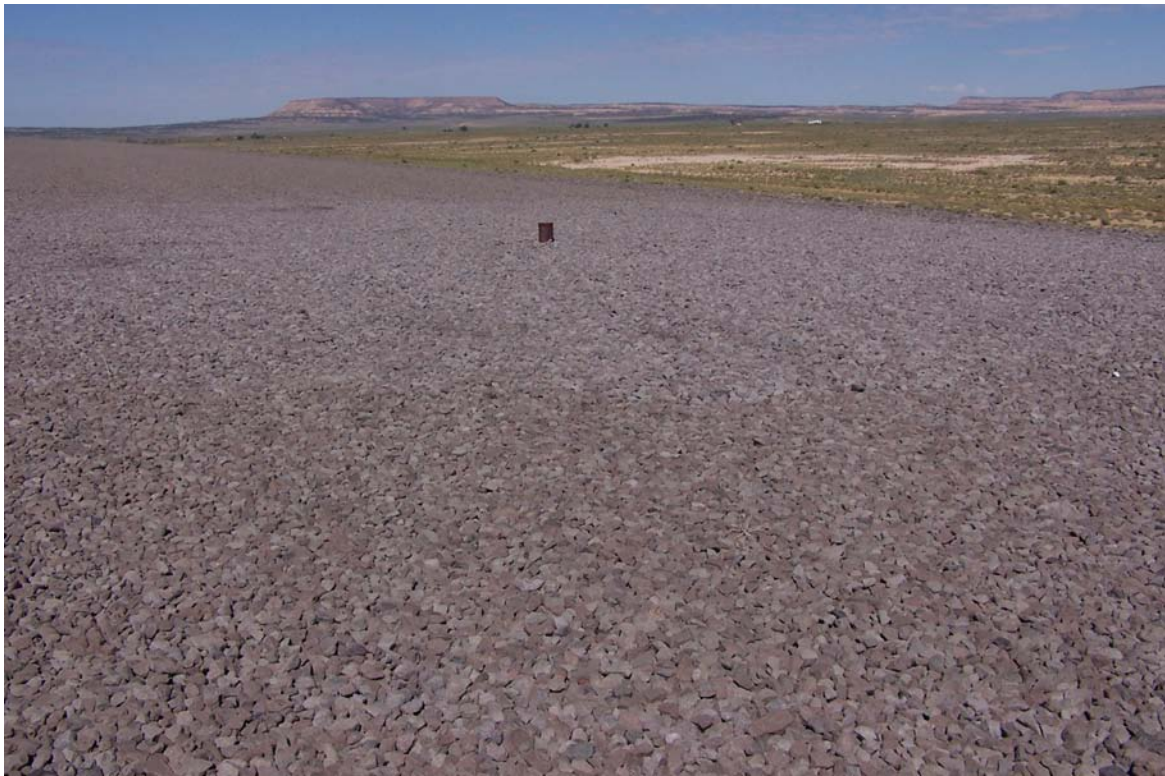
A shallow depression around settlement plate SP-4, near the northeast corner of the disposal cell cover, was first noted during the 1997 inspection and continued to grow in depth and area in subsequent years. The depression was repaired in August 2005. Surveys of the eight settlement plates in September 2005 and September 2006 indicate that the cover is stable and no new settling has occurred at SP-4. One more post-repair survey is planned for 2007. After that survey, settlement plate surveys will be conducted only if visual inspections indicate significant settlement on the disposal cell top.

AMB 8/2006. PL-3 Repaired settlement area surrounding settlement plate SP-4.

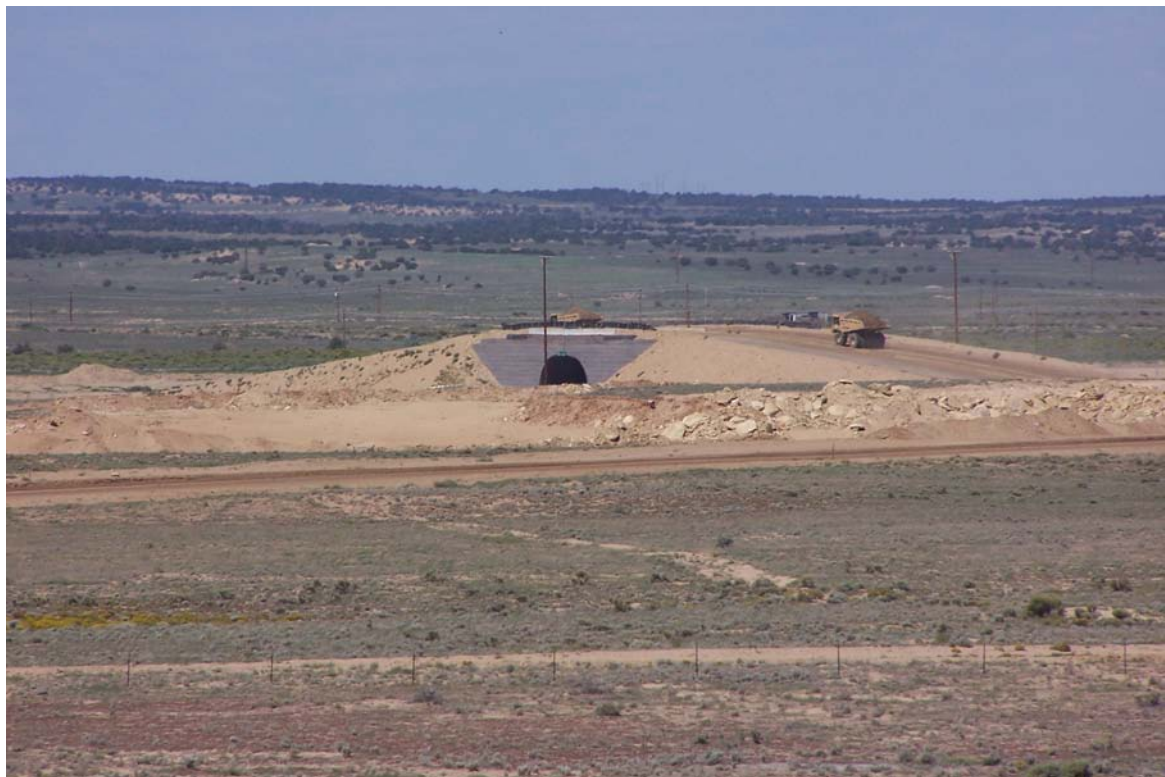
AMB 8/2006. PL-4 Loaded haul truck crossing recently constructed Rio Algom haul road bridge over Highway 509.

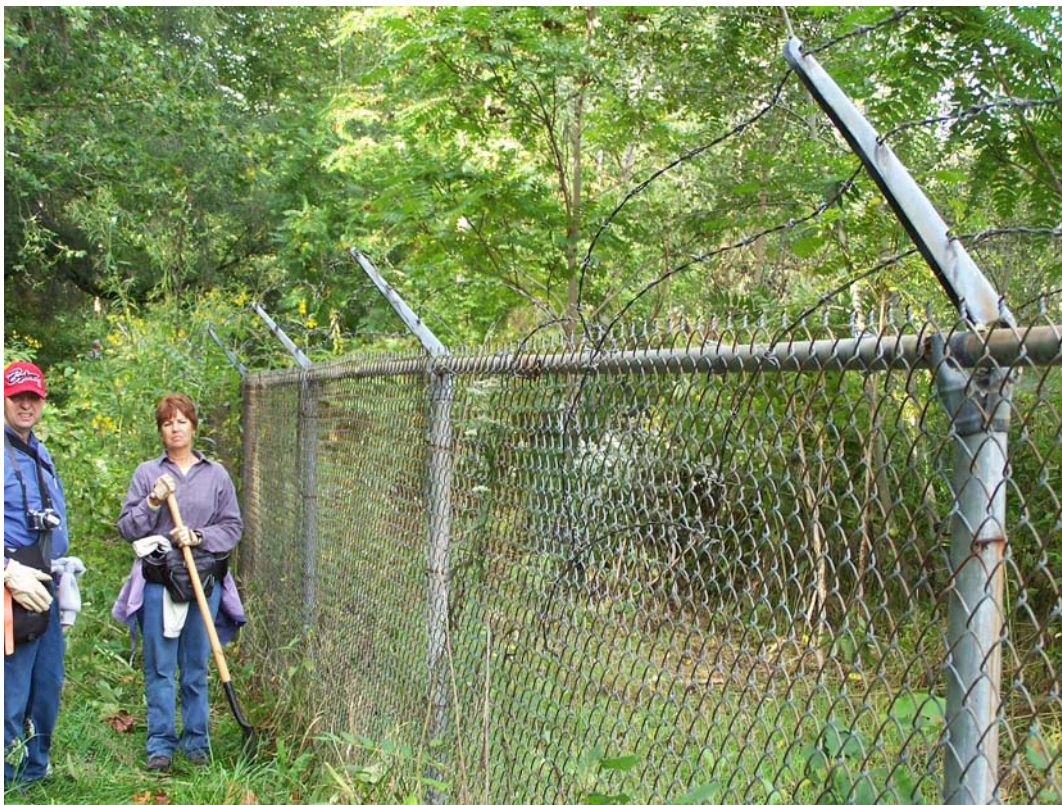
BUR 9/2006. PL-1. Broken strands of barbed wire on south fence line.

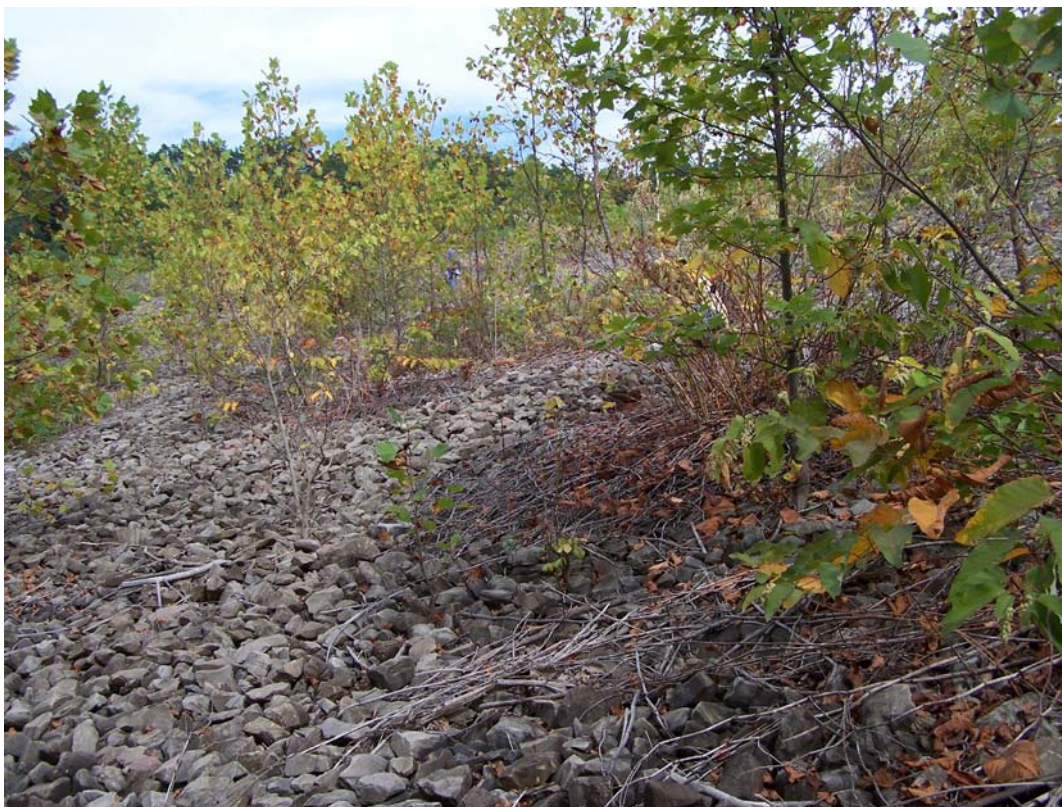
BUR 9/2006. PL-2. Vegetation growth on the disposal cell south side slope.

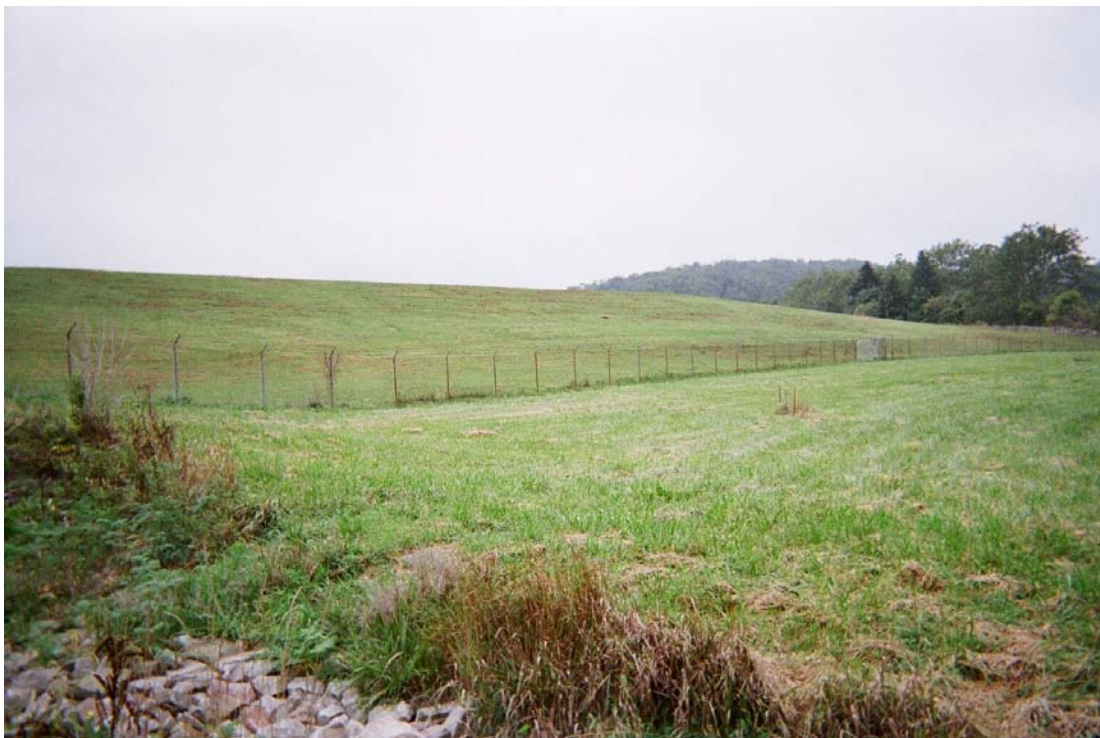
CAN 9/2006. PL-1. Turf condition on northeast site slope.

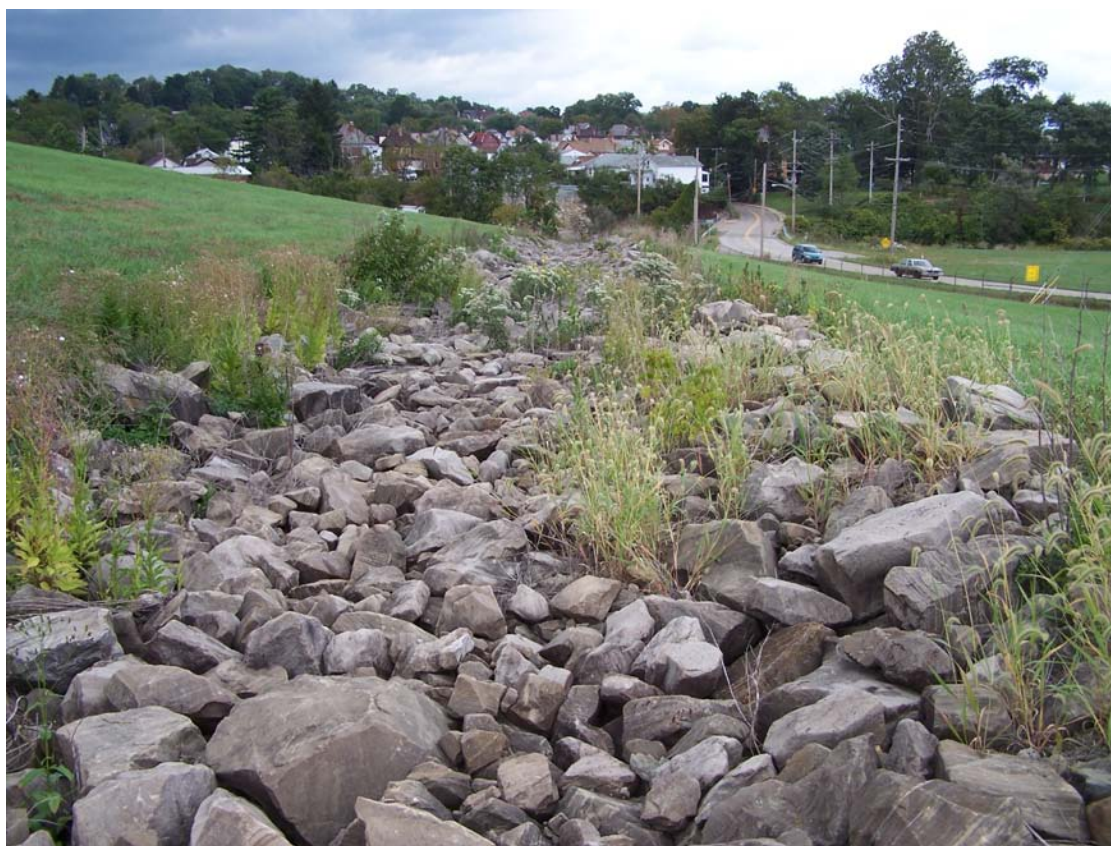
CAN 9/2006. PL-2. Vegetation in diversion channel.

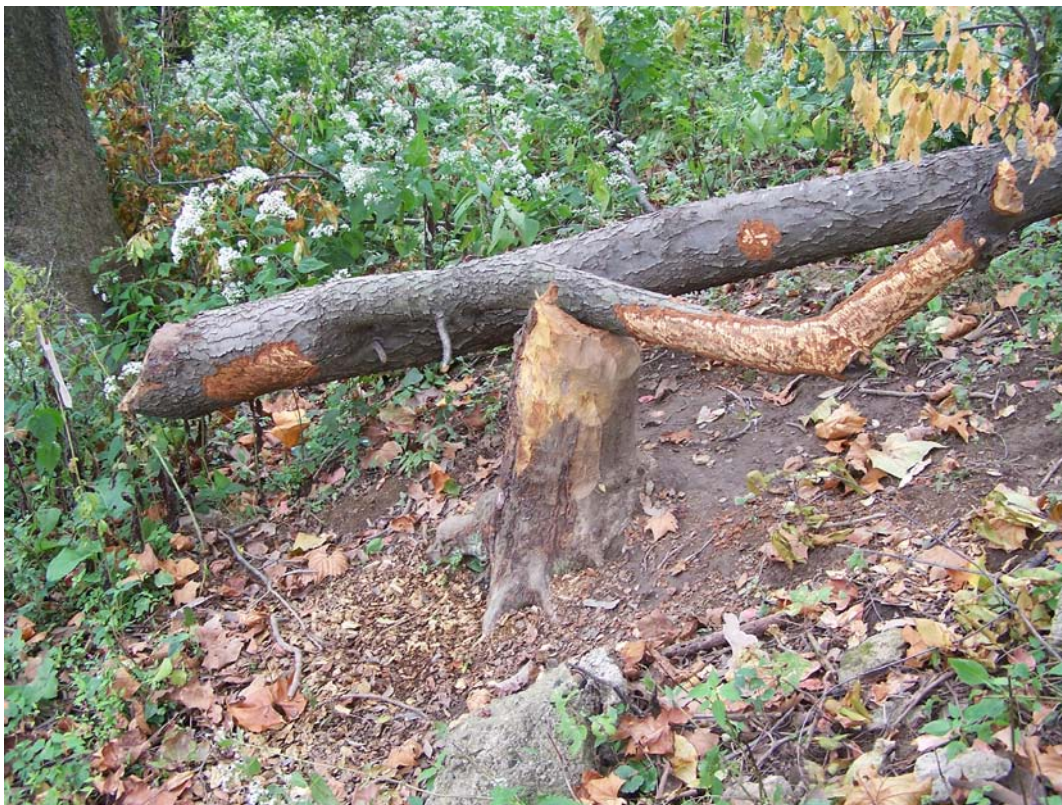
CAN 9/2006. PL-3. Beaver damage along Chartiers Creek.

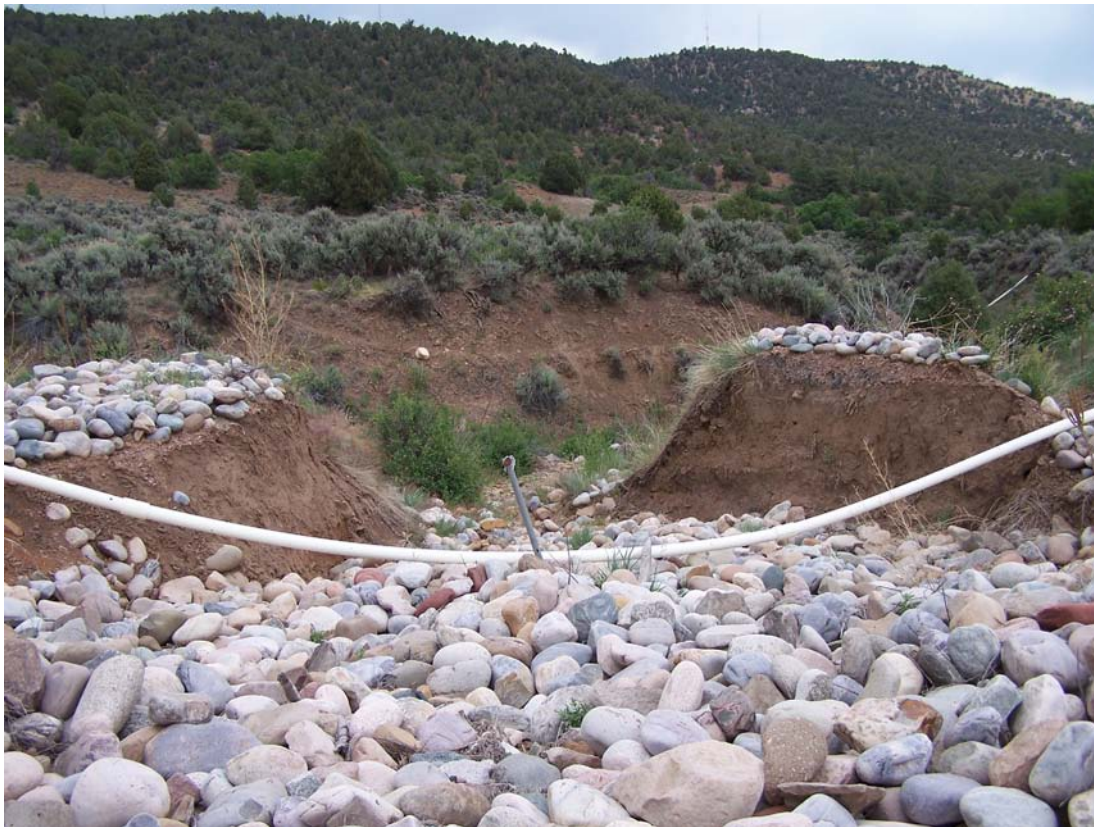
DUR 6/2006. PL-3. Northeast Outflow; no new erosion.

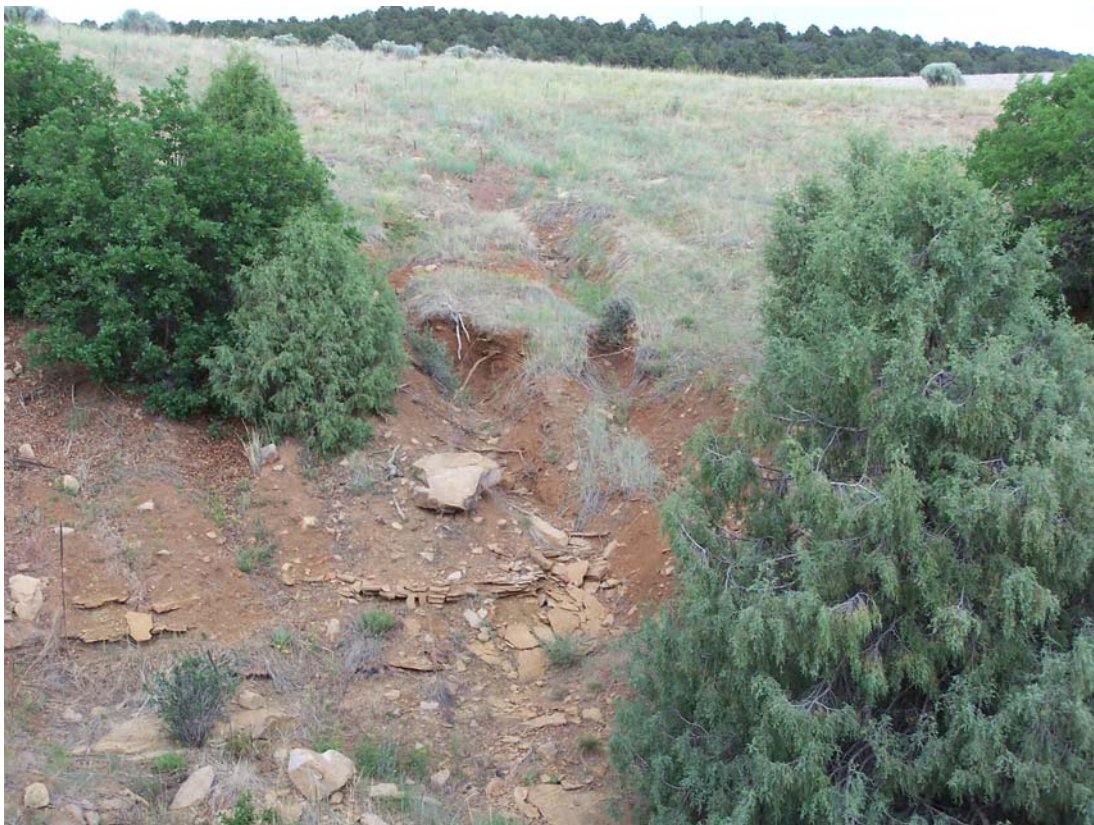
DUR 6/2006. PL-4. Fresh headcuts in gullies in the southwest portion of the site.

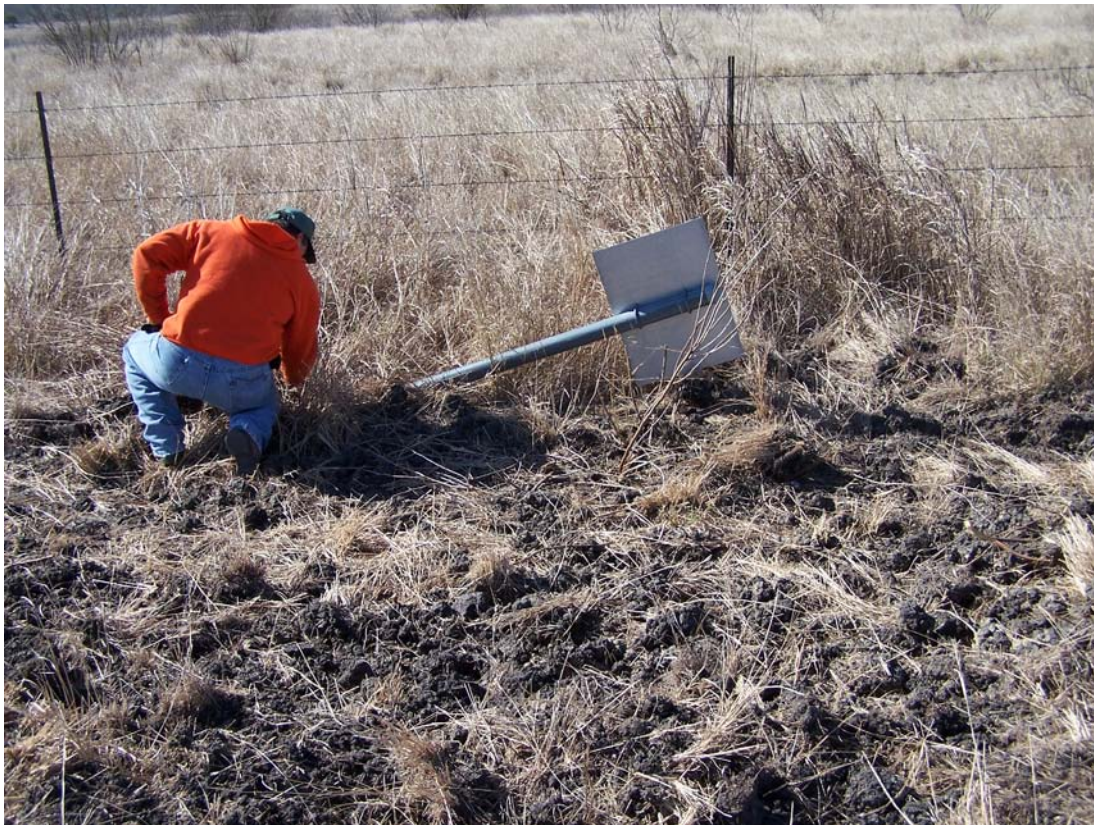
FCT 1/2006. PL-3. Perimeter sign P20; damaged.

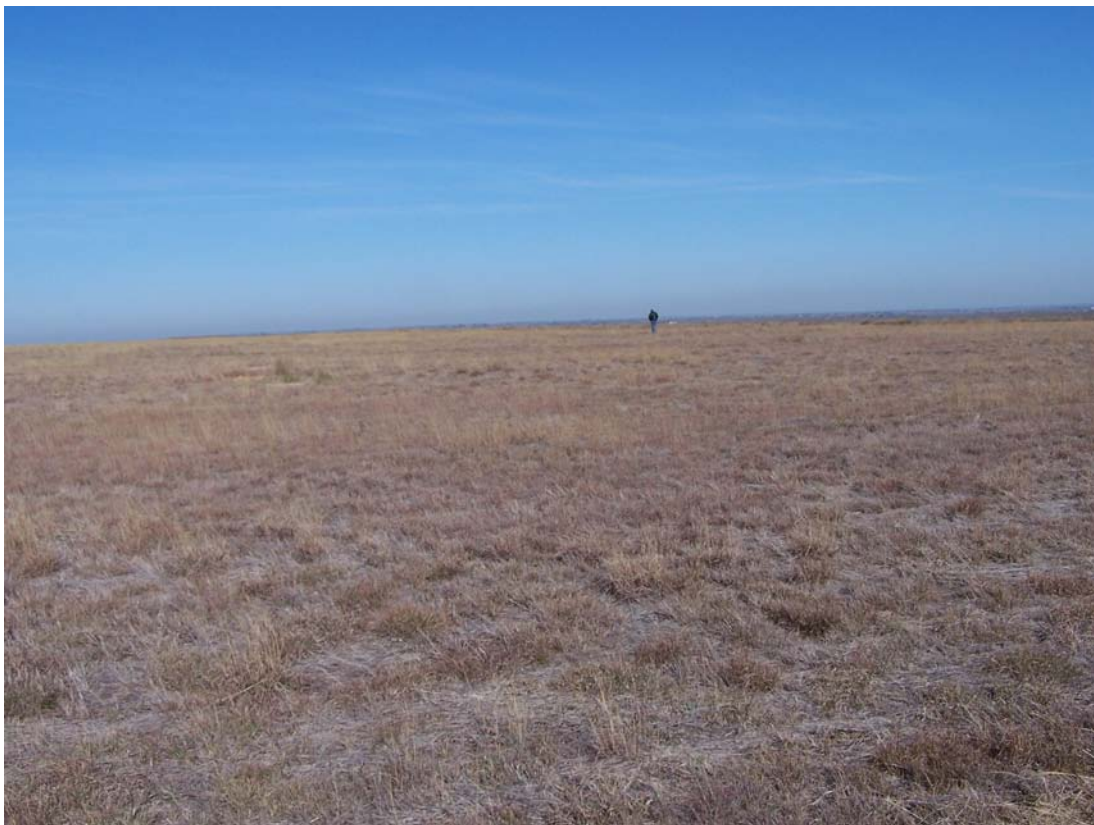
FCT 1/2006. PL-4. Top slope of the disposal cell showing well established grass cover.

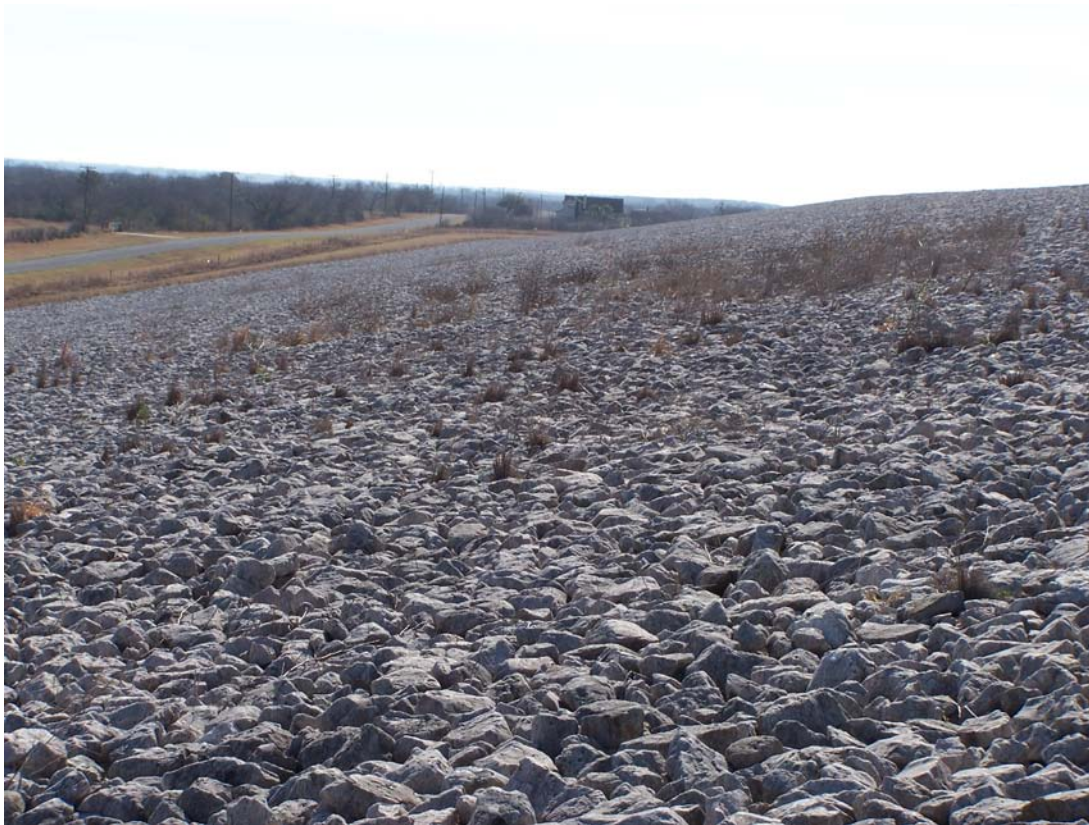
FCT 1/2006. PL-5. Undesirable vegetation on northeast side slope.

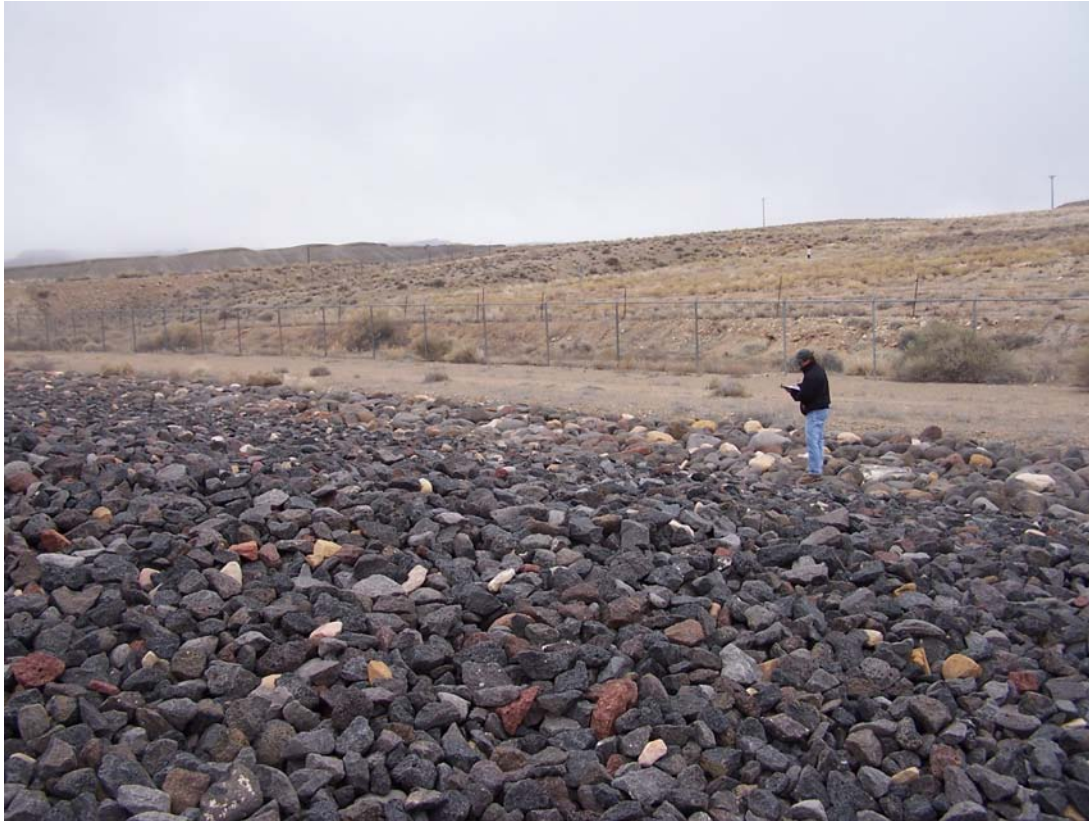
Disposal Cell and Adjacent Area Inside the Security Fence—The slopes of the disposal cell cover are armored with riprap (PL-1). The cell cover was in excellent condition. The riprap apron along the base of the disposal cell on all sides was in excellent condition.

GRN 3/2006. PL-1. The southeast side slope of the disposal cell.

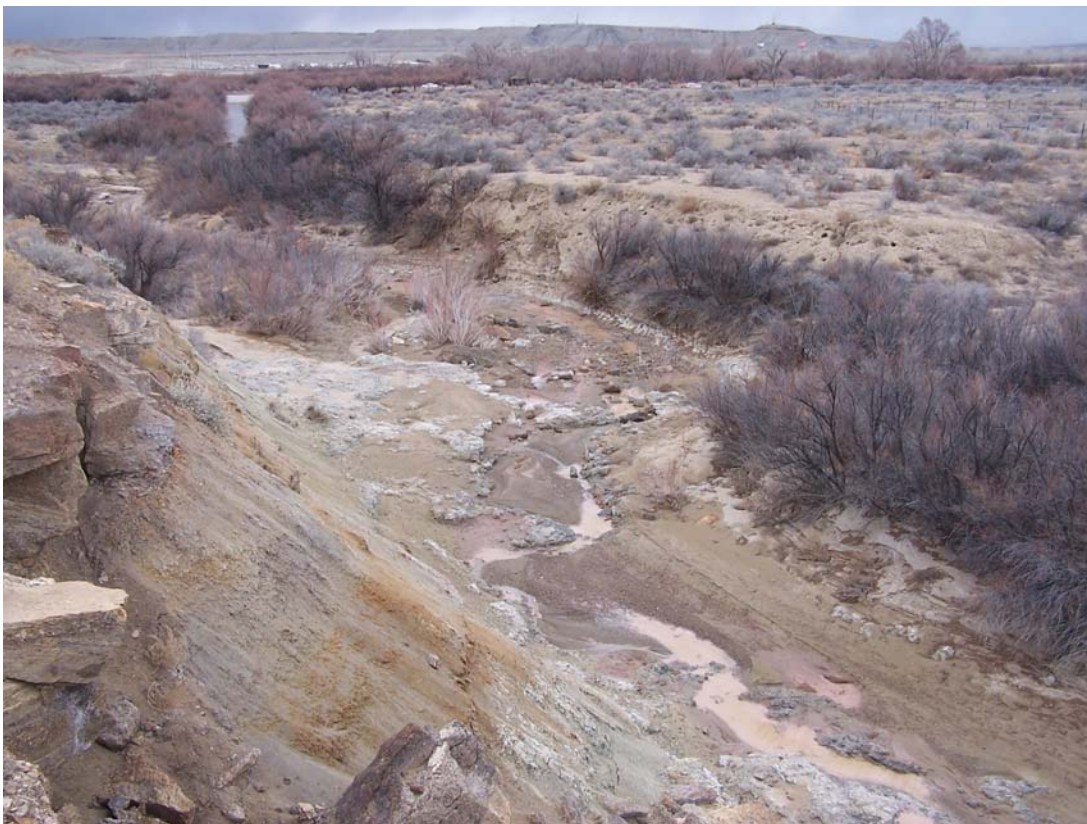
GRN 3/2006. PL-3. Pools in scour holes below Cedar Mountain Formation outcrops in Browns Wash (view downstream toward the Green River).

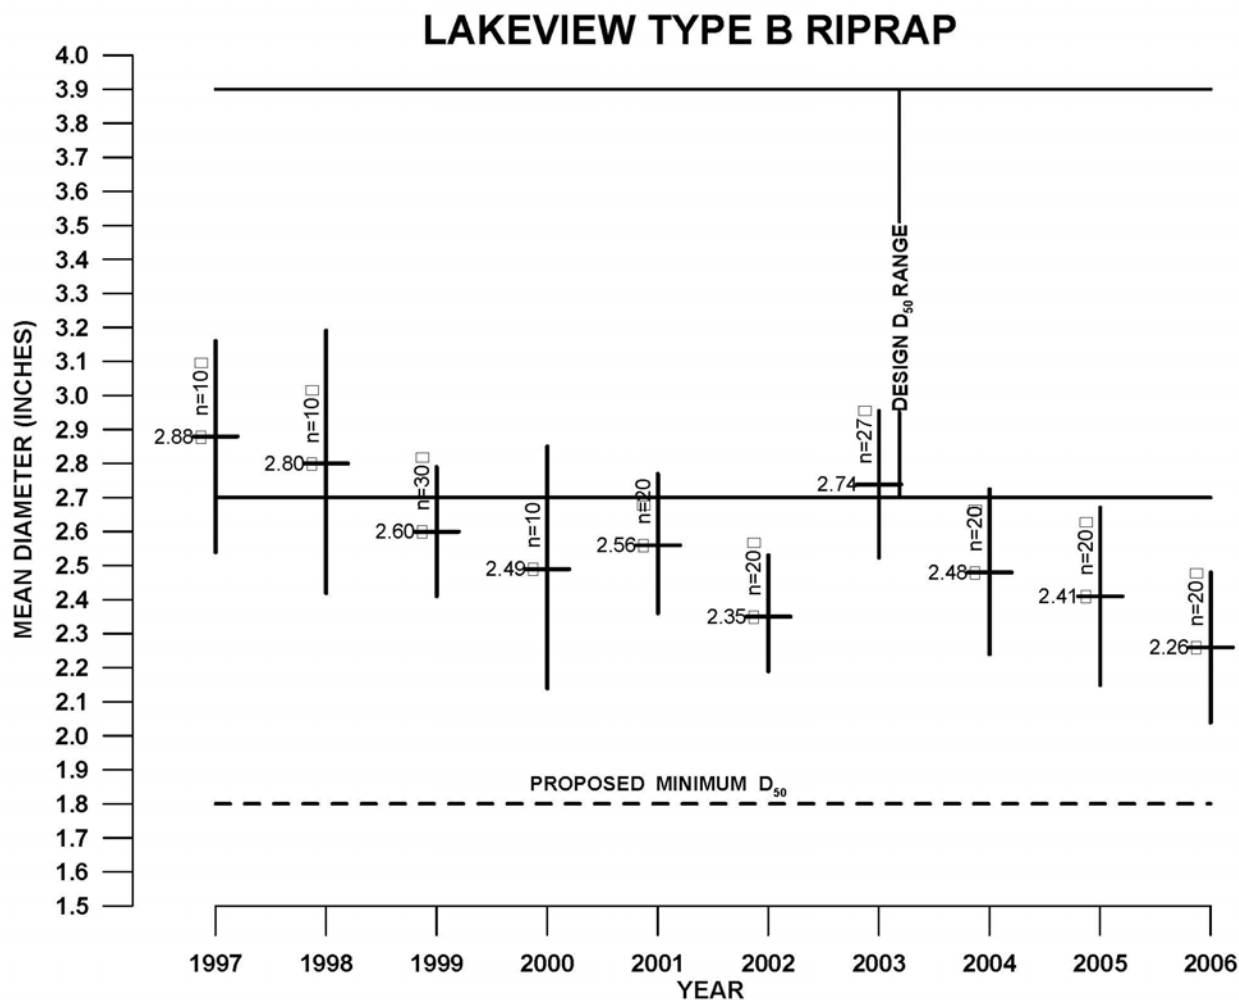
Figure 9-2. Side Slope Riprap Gradation Monitoring Results for the Lakeview, Oregon, Disposal Site

Annual rock gradation monitoring of side slope riprap was performed for the tenth year during the 2006 inspection (PL-3). Particle size distribution (weight percent) by count data was collected at 20 locations. The 2006 results indicate an average D_{50} of 2.26 inches with a 95 percent confidence interval between 2.04 and 2.48 inches (Figure 9-2). The mean D_{50} in 2005 was 2.41 inches. The D_{50} value measured for 2006 is similar to values measured for most of the previous 5 years: 2001 ($D_{50} = 2.56$), 2002 ($D_{50} = 2.35$), 2003 ($D_{50} = 2.74$), 2004 ($D_{50} = 2.48$), and 2005 ($D_{50} = 2.41$). The average D_{50} for the previous five years is 2.51.

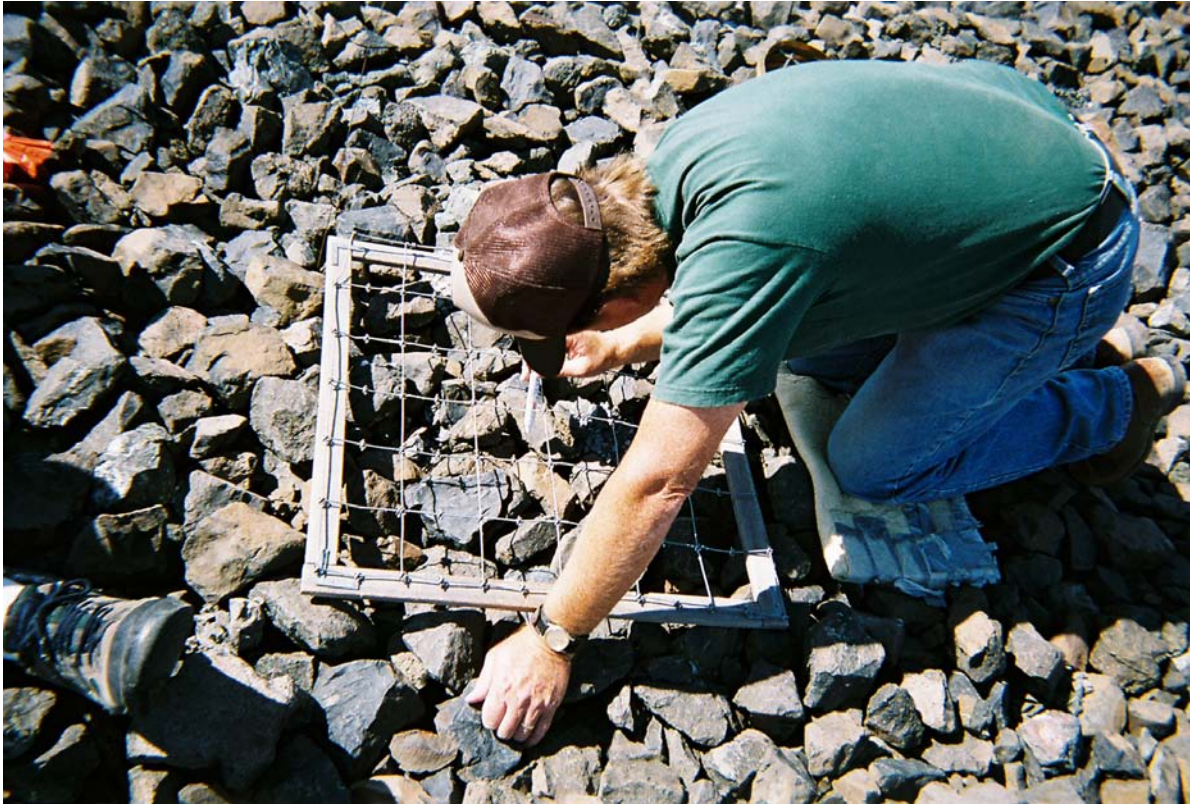
LKV 7/2006. PL-3. Measuring riprap size on the side slope of the disposal cell.

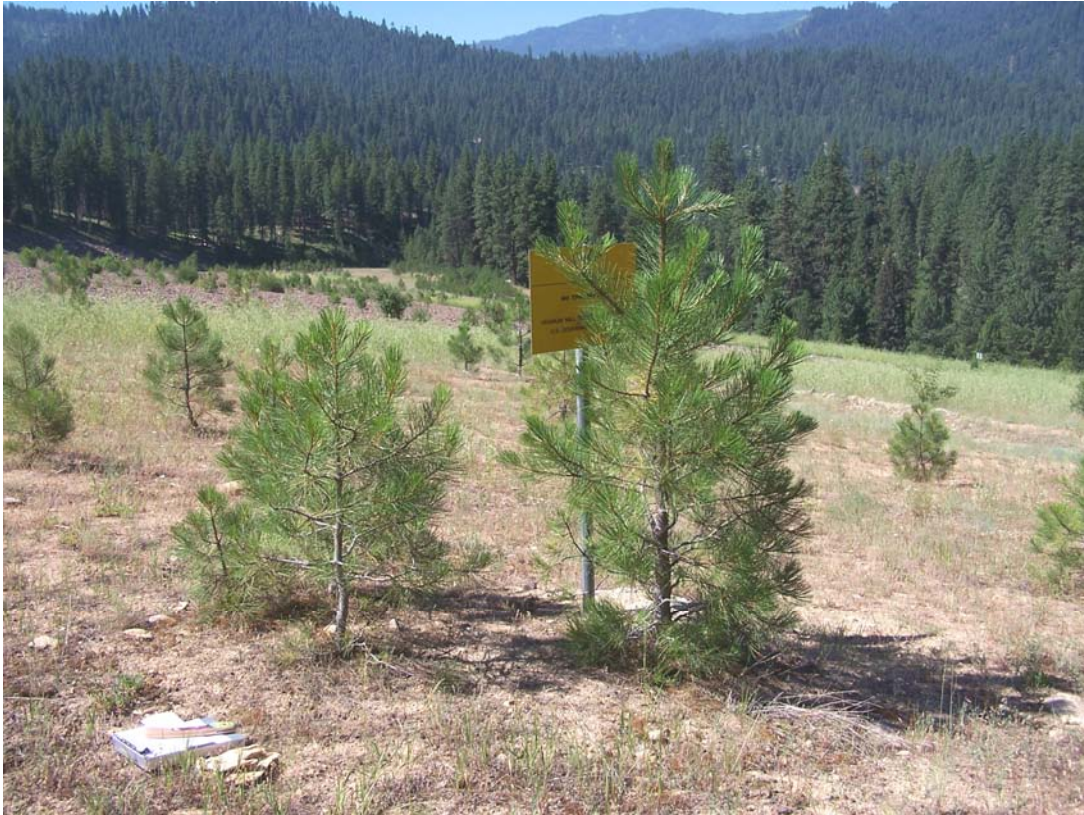
LOW 7/2006. PL-1. Ponderosa pine trees obscuring view of perimeter sign P6.

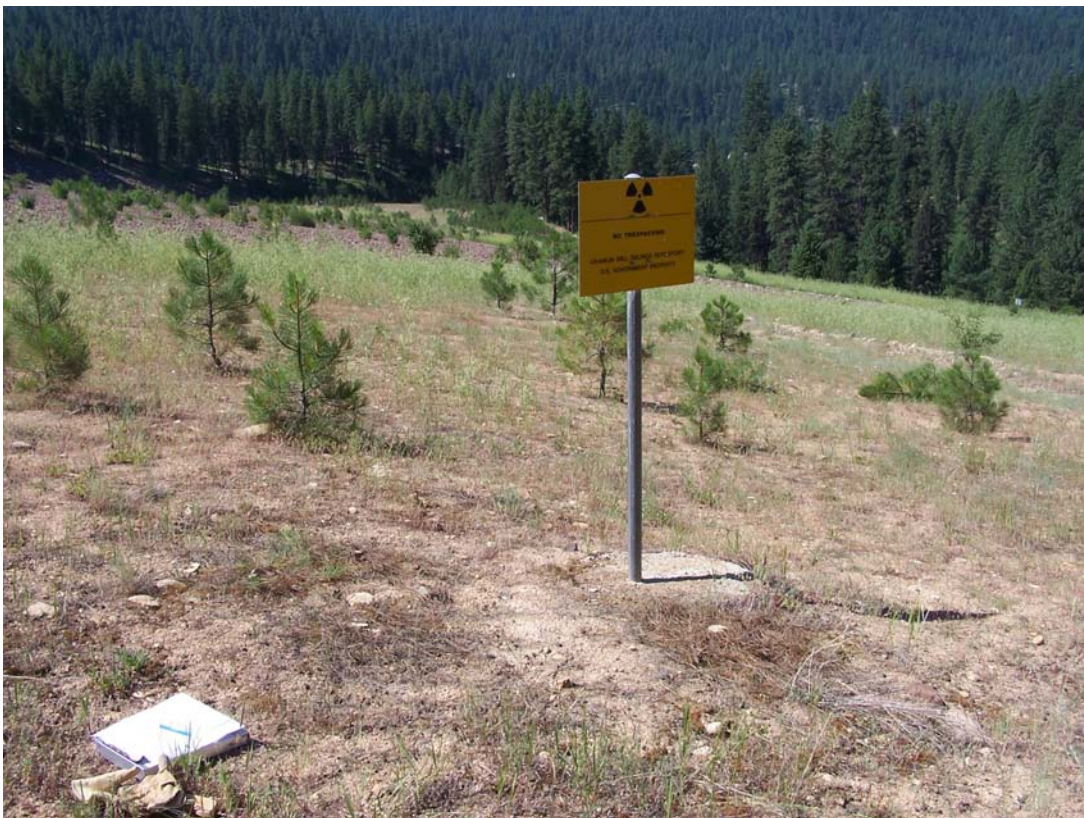
LOW 7/2006. PL-2. View of perimeter sign P6 after removal of the pine trees.

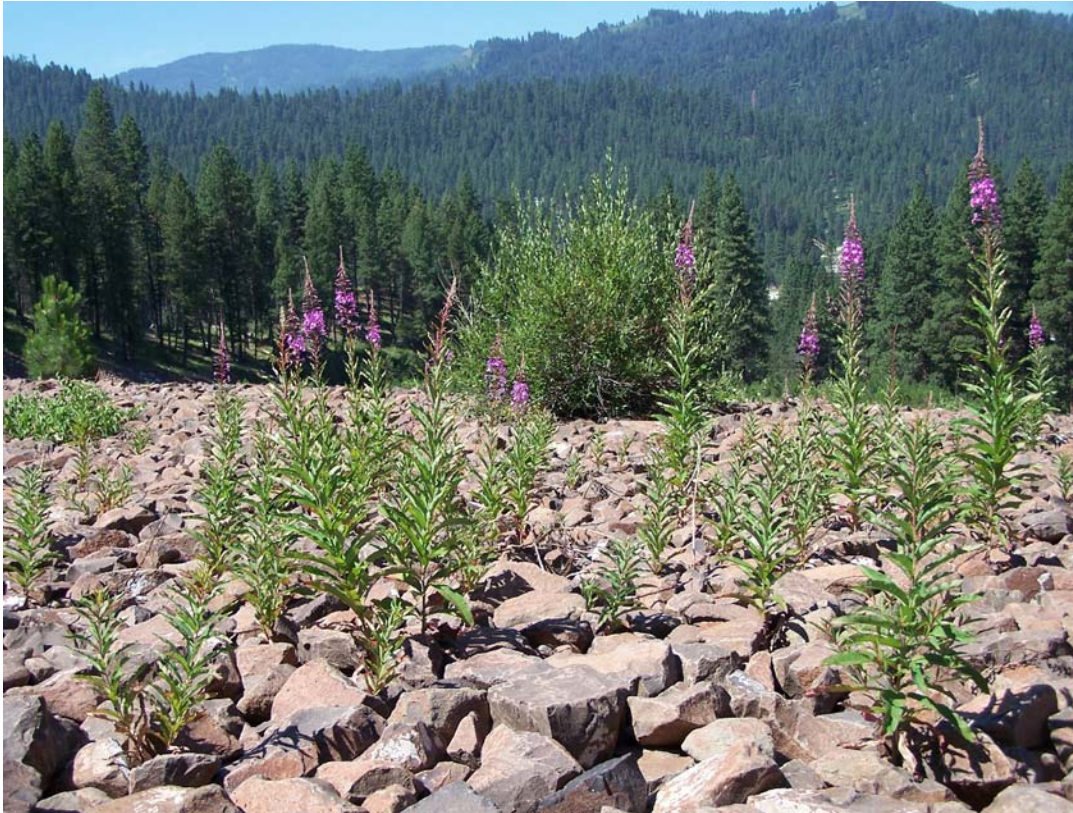
LOW 7/2006. PL-5. Fireweed, redosier dogwood, and ponderosa pine on the cell top.

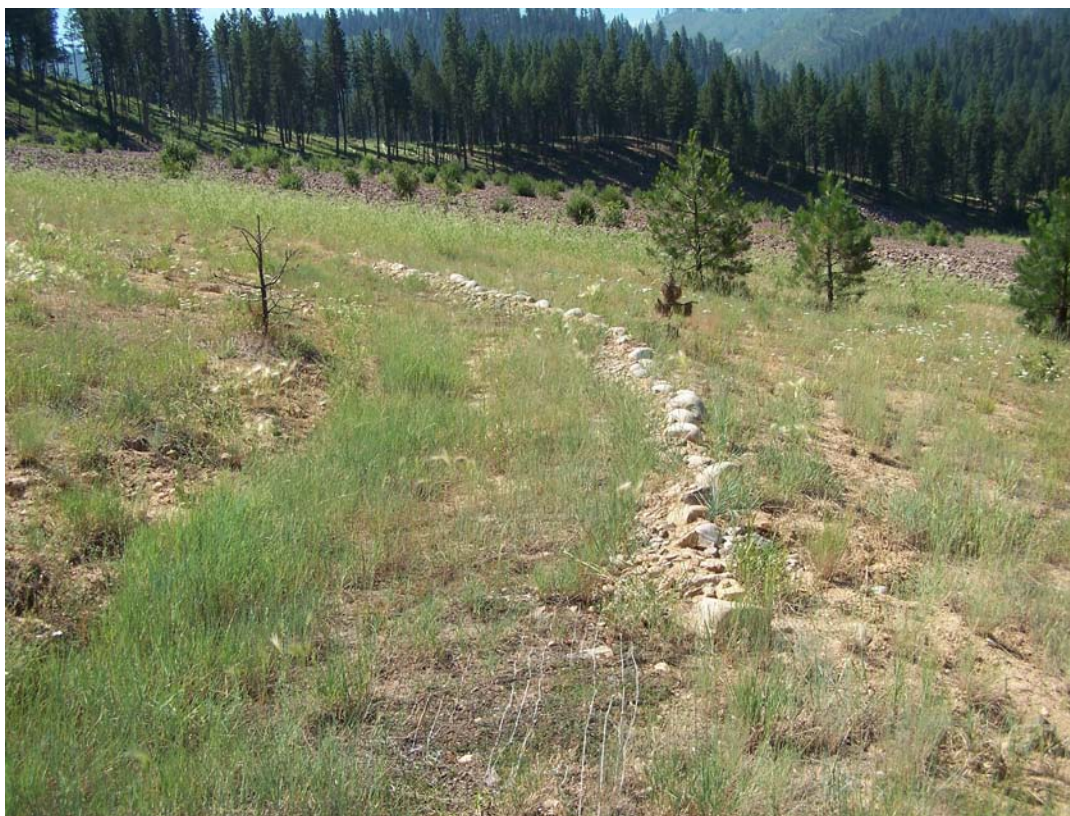
LOW 7/2006. PL-7. Repaired area on south end of Interceptor Bench 1.

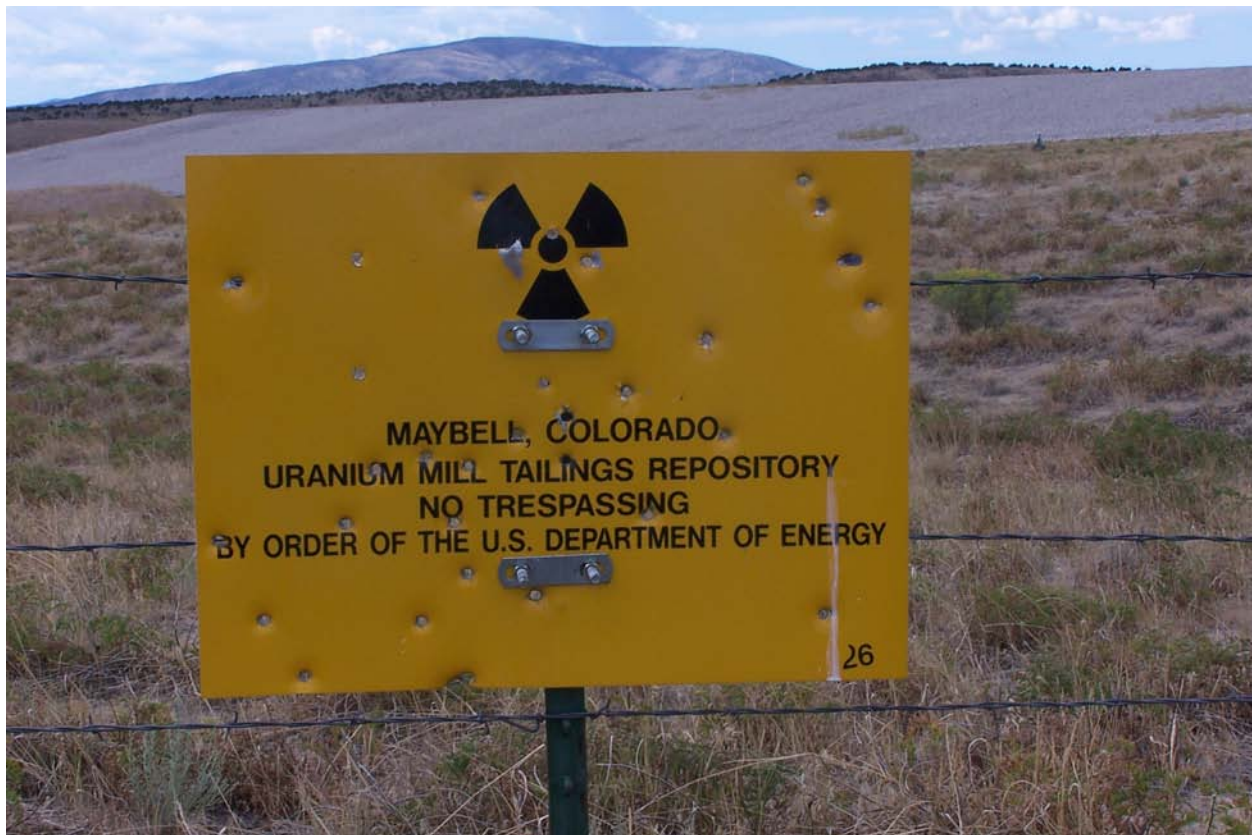
MAY 8/2006. PL-1. Perimeter sign P26 showing bullet holes; legible.

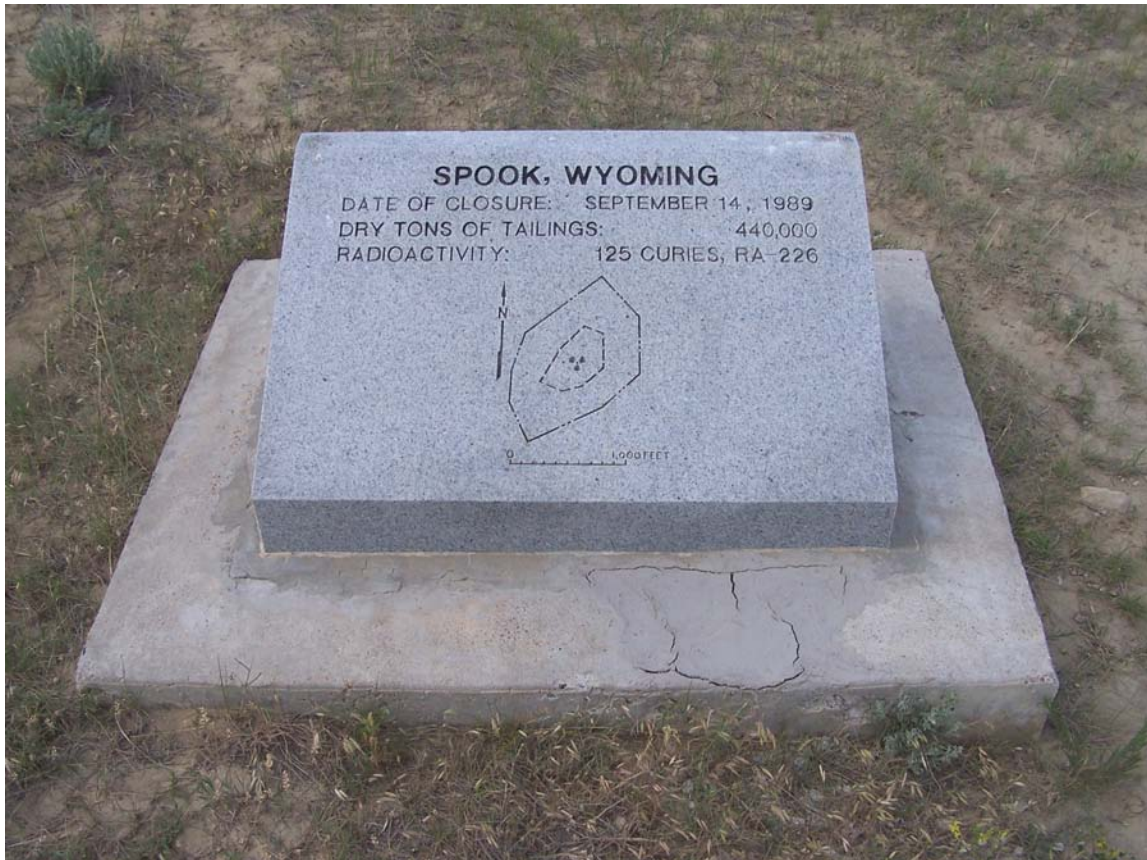
SPK 6/2006. PL-1. Site marker SMK-1, showing cracking of patched concrete.
